Methodical conflict among the ways for drying out of historic masonry

ORIGINAL SCIENTIFIC ARTICLE

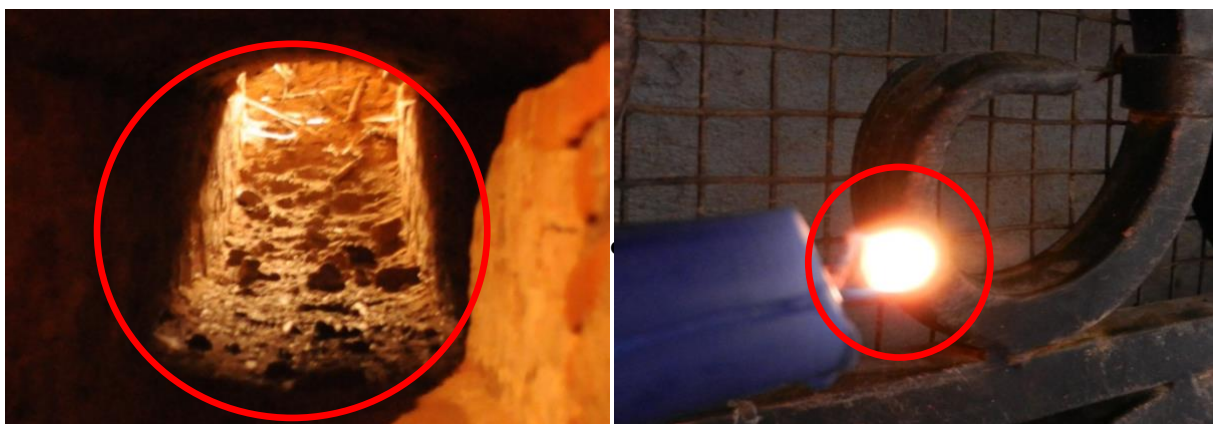
Fig. 2 The ventilation opening of the crypt (left) and a strong flow of the air inside of it (right)

The first step, which was recommended was the opening of the original ventilation holes in the crypt, which were closed probably during the 40-ties of 20th century. Thanks to this action the quality of the interior air in the crypt raised dramatically to a level where comfortable breathing was possible. It has to be mentioned, that there were dozens of cadavers of dead people buried in the crypt before.

After the original ventilation was set into action also the contents of relative moisture in the masonry lowered. But it was still not enough, as the masonry stands humid. But in any case, the situation was better and a chance for new use of the crypt, for example for prayers was made possible. The function of the ventilation was afterwards proofed by using the flame of a candle.

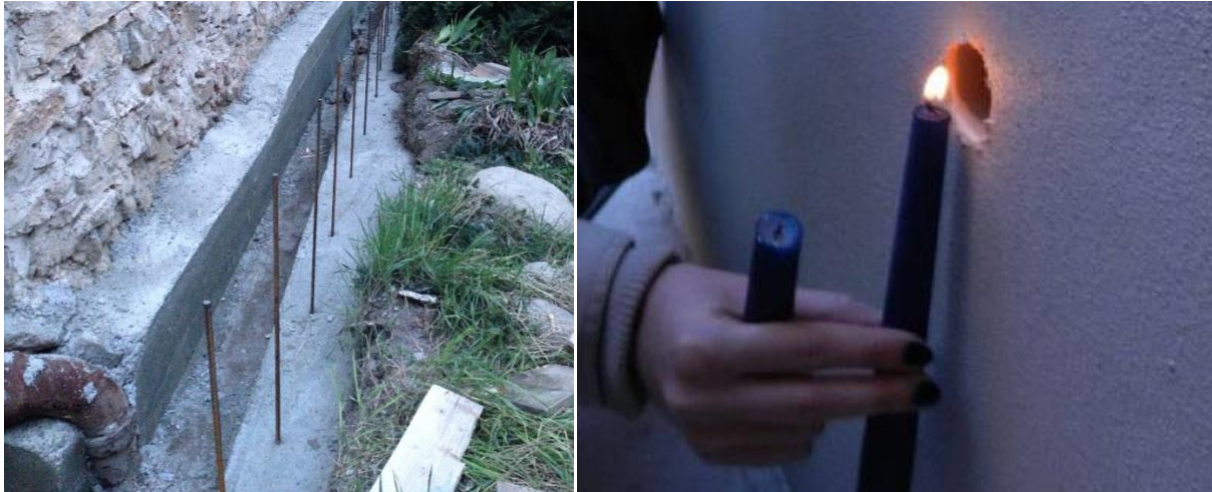
Fig. 3 The New made “ventilation” channel around the basements which stands, because of the use of concrete (left), beyond repair and the minimal air flow in this channel was proofed by a candle (right)

Unfortunately, the monks did not follow our recommendations and they gave in to a practical engineer, who submitted them his own way how to deal with the moisture. He constructed a “ventilation” channel around the baroque basement of the church and sacristy.

The use of ventilation technology showed its limits. After setting the original ventilation system in the crypt into function, the level of moisture in the church went down, but still not sufficient. Generally, this was around 3 to 7 % in the interior of the church, or 1 to 3 % in the crypt. Construction of the ventilation channel [3 – 6] around the basement of the masonry was not enough sufficient, but helped to raise the level of moisture in the masonry up.

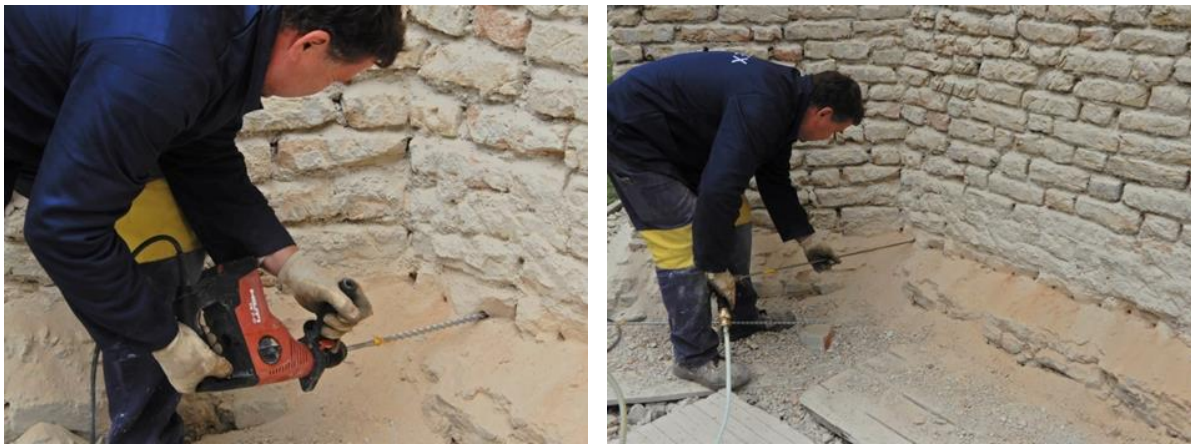
Fig. 5 Drilling boreholes (left) and injecting them with a creamy sealing barrier (right).

The technology of injecting of the masonry is one of the more effective and less invasive. It is based on drilling of opening in the masonry which are afterwards used for injecting a liquid, or creamy sealing agents into them. The agents can be transported by using of atmospheric pressure, or by using of higher pressure produced by an injecting machine. The second mentioned way is more effective as it transports the agent more deeply and widely into the masonry [1, 14, 15].

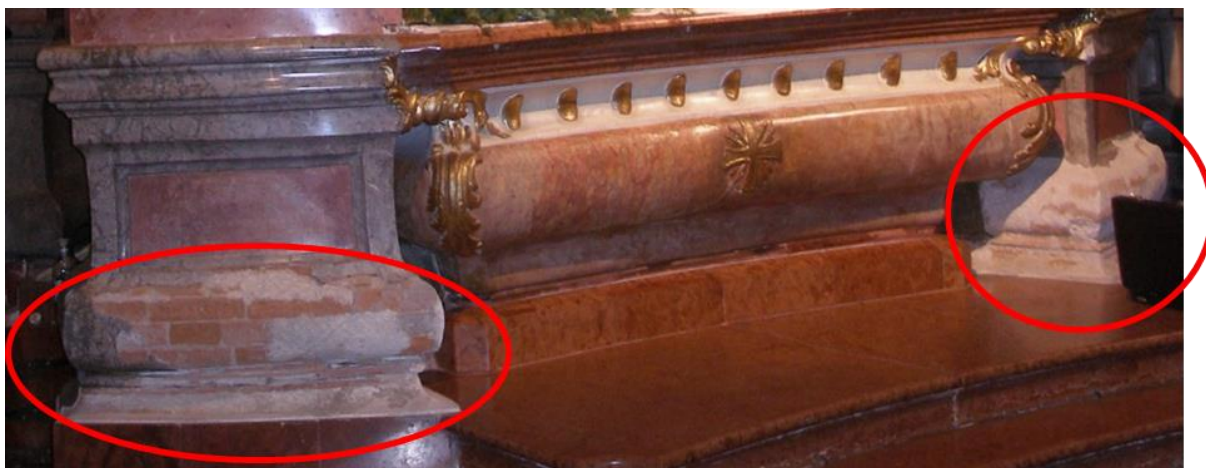
Fig. 6 Visible damages on the baroque altar.

As an example of effectiveness of such technology the injecting of the basis of the baroque altar in the town Nitra can be listed.

Like it is visible, after the injecting of the basis of the altar with a liquid sealing barrier in the mid of the year of 2011 the situation went immediately better only on half of its construction. The rest went better after about two years. As there was no possibility to examine the construction material inside of the altar we can only expect, that there was different material used in both sides of its construction, which caused a different reaction on the introduced sealing material. This could explain the much slower insulation reaction. Finally, after three years the situation was already satisfactory. There were no more measurements undertaken, so we can only expect that the level of moisture went in the following time even more down.

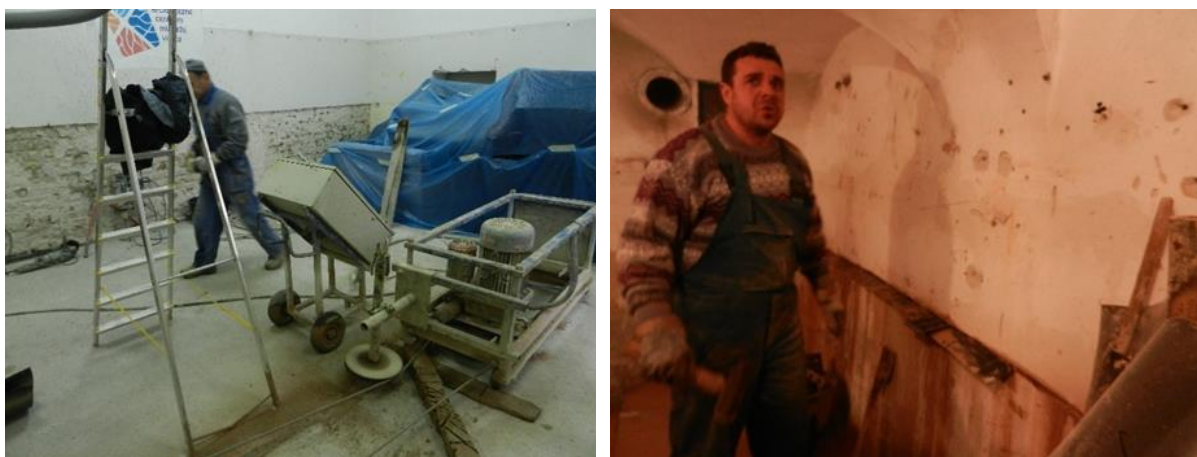
Fig. 7 Process of undercutting the masonry (left) and placing a solid insulation foil in the sawed gap (right).

This technology is based on cutting the masonry mostly, but not only in horizontal level. The cutting is in nowadays times achieved by the use of a special machine with an endless rope enforced by diamonds, which circulates through it and through the masonry. As a result of the cutting process a cutting gap appears, in which an insulation foil can be afterwards placed [14, 15].

There is also a couple of risks and complications connected with the introduction of this technology, which have to be solved. The avoidance of such complications depends mostly on experiences of the realizing company. The major complication, which can be even crucial is in the possibility, that the cutting gap could not be secured enough. Thanks to it the enormous weight of the above standing masonry will settle in it. As a result of such process cracks will appear in the constructions. That is why special chocks needs to be placed into the gap immediately after cutting the masonry.

The process of placing the insulation foil into the gap has a limit in the thickness of the masonry which can be effectively insulated. It can usually stand around 1,20 m, maybe 1,30 m. If the wall is thicker, the insulation needs to be placed in it from both sides. That is why the final limit of the effectively insulated wall stand around 2,50 m. But in most of the cases this can be enough.
