VERIFICATION OF THE METHOD FOR ASSESSING THE SEVERITY OF THE CONDITION ETICS WITH BIOCORROSION

doc. Ing. Antořová Nad'a, Ph.D.; Ing. Petro Marek, Ph.D.

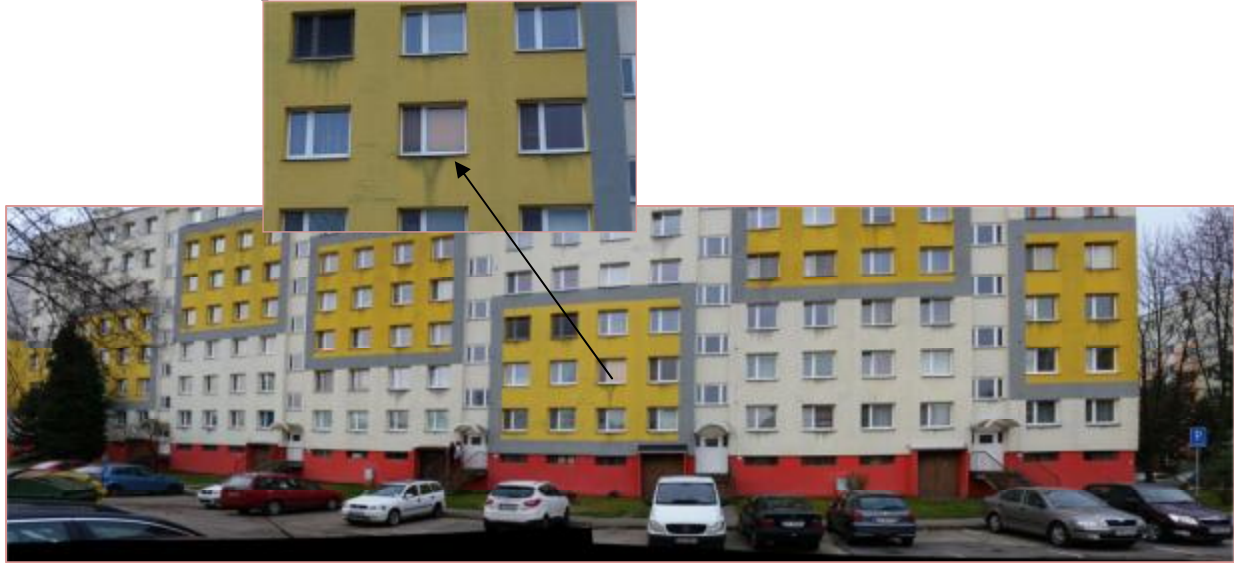
The subject of research was the facade surface with thermal insulation and visually identified "soiling" mostly black or green colours that occur on the north-facing side, locally, in areas under sheeting windowsills, in typically vertical direction and in surface typically horizontal band display. Multicolour facade is depicted, with predominant shades of white contrasting with saturated yellow and gray. From a visual diagnosis of the occurrence of microorganisms it showed that only colonized is the surface of ETICS mostly by microorganisms of green or black colours, unprotected with slime. On the surface, there were no cracks or defects. From the colour scale of biological material can be estimated origin of microorganisms, while the green colour indicates the presence of algae with a higher need for external humidity and black coloration indicates the presence of micromycetes or dead algae residues. Visual perception of soiling facade tells about the exceeding the critical values according to [2], i.e. degree 3, when the moderate pollution up to 5% of the area passing through the evaluation on secondary pollution, which is colonized by up to 25% of the area. According to the three-stage evaluation mechanism of severity of technical condition it is a aesthetic deficiency that does not affect the functionality or security ETICS construction and the consequences can be remedied

by normal cyclical maintenance. Locally, however, there were recorded locations, copying the run-off from windowsills in low lining or escape of heat from the interior in contact with the window frame and windowsill, the equivalent to 5% of the total area.

Fig. 1: North Side - contamination by the biological materials (author)

Based on a visual survey, the first planned conclusion and evaluation of thermal insulation with microbiological attack was marked as aesthetic deficiency, without finding surface breaking cracks, peeling off and other deformation of the construction. Colonization, calculated on the facade area by free observation did not exceed the 25%. There have also been reported locally raised "colourfulness soiling". Protection of microorganisms with slime was observed.

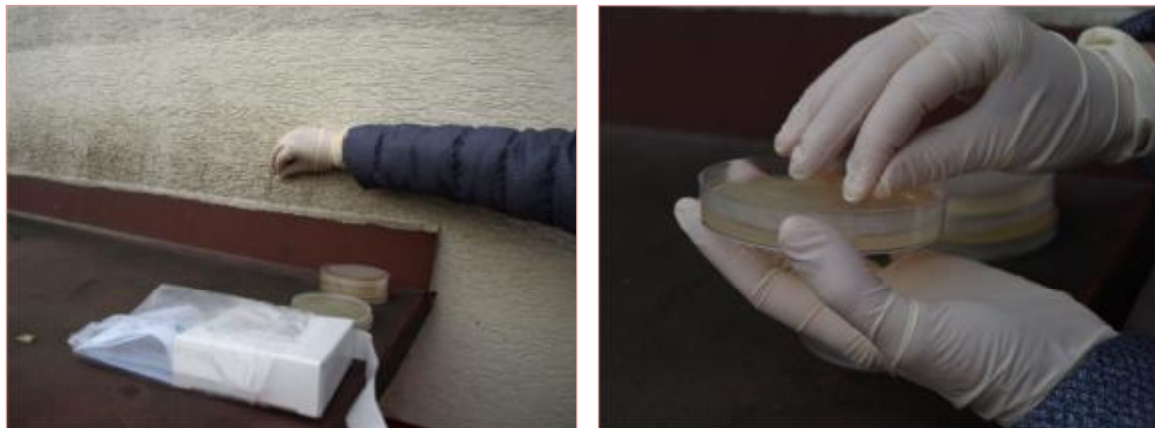
Fig. 2: Practical performance - taking of samples with piece of tape from the surface of contaminated plaster (author)

Taking of samples were carried with piece of tape:

- examined facade with different coloured finish with no visible fungal increase,
- examined facade with gray, black and green spots possible fungal to algae growths),
- holes by destructive probe from ETICS plasters,
- samples from control buildings opposite the examined facade with no visible colour change, green or black deposits, one plaster was of the same type on the insulation construction and another plaster based on lime.

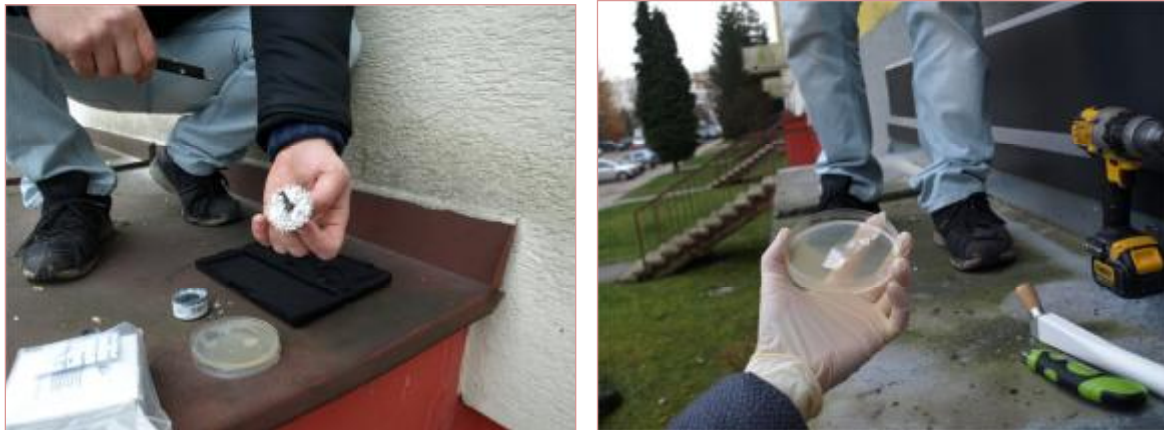
Fig. 3: Practical performance - taking of samples with piece of tape under the surface in contaminated areas. It is a basis for assessing of biodegradation activity and proposed solutions (Author), [5].
