RENOVATION OF ROOF STRUCTURE OF HISTORICAL BUILDING – CASE STUDY

Ing. Marcela Spišáková, PhD.¹; Ing. Daria Mokrenko^{1*}

¹ Technical University of Košice, Faculty of Civil Engineering, Vysokoškolská 4, 04200 Košice, Slovakia

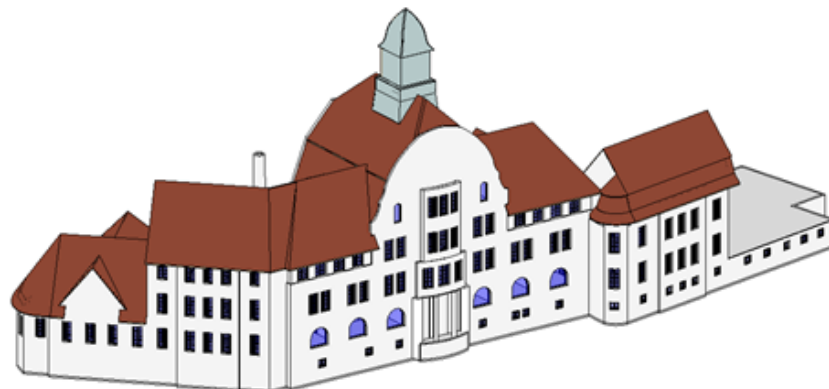
Fig. 2 3D model of OTH from the south side in REVIT software

The FARO Focus 3D X130 3D scanner was used to determine the contemporary state of the building roof structure. The 3D slope roof structure model was created in the REVIT software (Fig.2) based on 3D scanning (by point cloud). Through the detailed processing of the 3D model, it was found that OTH slope roof structure is formed by 1031 elements (Fig. 3). The eastern part of the building has not been solved. There is an office of the President of the Slovak Republic. Due to this, for security reasons we were not allowed to access into this space for the processing of contemporary state of the building.

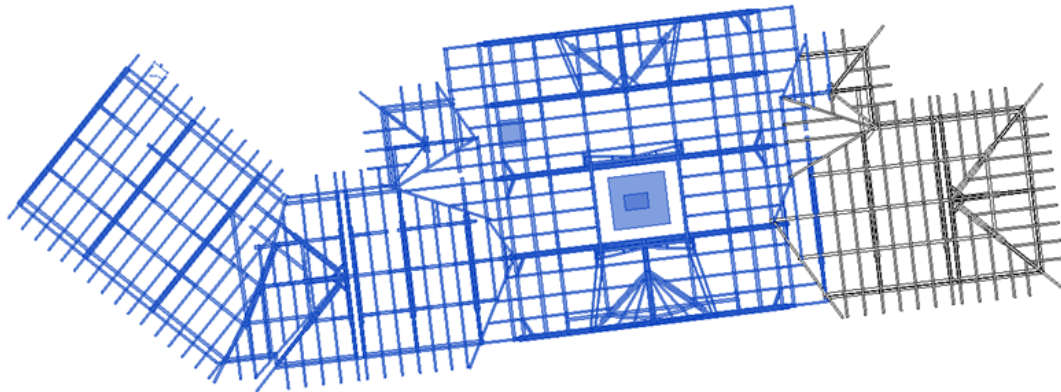
Fig. 3 Drawing of the building "Old Town Hall" roof

The building was built in 1912-1914. The roof of the building consists of several materials. Above the highest central part, the saddle is terminated by triangular shield, above the risalit, large shields are inserted on both sides, passing into the mass of the roof by a half-shell, above them a superstructure of a clock tower with a sheet metal roof. Roof is accessible from the last floor hallway. The construction of the slope roof structure is a standing chair. Roof covering is ceramic tile, plain tile. The gable roof is on external roof sections: on the east side are inserted gable shields, on the west side are hemisphere and hipped roof. The gable roof and hip roof are on the wings of building. There is the same roofing than on the central part.

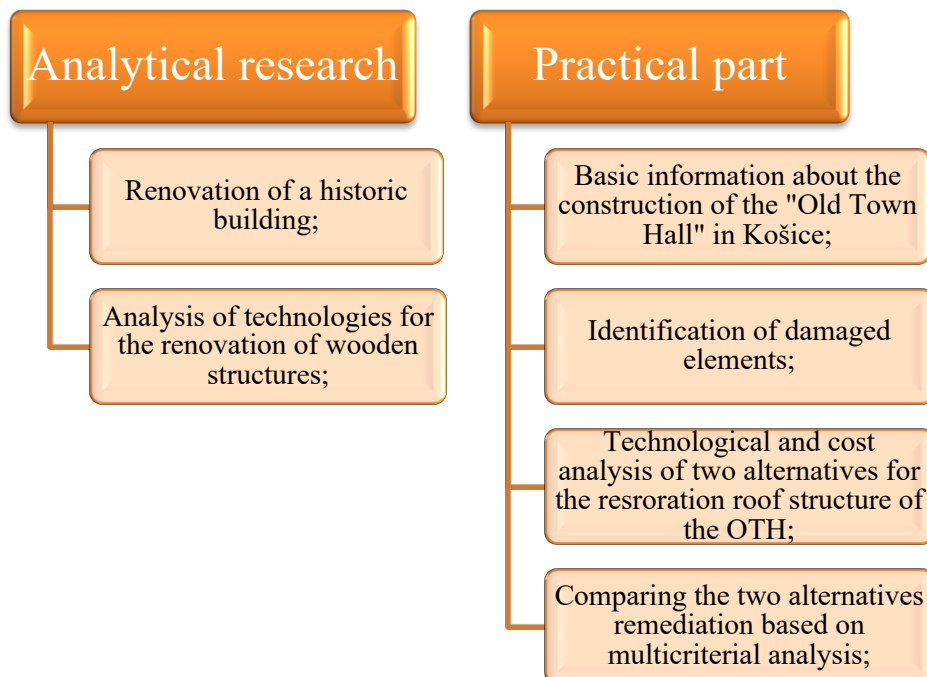
Fig. 4 Work methodology

The methodology of the work was divided into an analytical research and a practical part - a professional design of the slope roof structure renovation supported by a 3D model of the building (Fig. 4).

The analytical research includes an analysis of information related to the renovation of historic buildings, which describes the data as an approach to renovation, processing of knowledge related to the preservation of the historic building. The practical part included processing of the slope roof contemporary state structure by 3D laser scanning, description of the building, determination of the damage degree of the roof structure and subsequent description of the damaged elements in terms of statics, humidity conditions. These steps resulted in the design of options for the recovery of damaged elements. Specifically, it has been proposed 2 alternatives recovery of damaged elements. Based on the technological and cost analysis of both alternatives, evaluation parameters were acquired, which were subsequently used in multi-criteria evaluation using the method of index coefficients. In conclusion, according to the distribution of weights criteria it was determined optimal variant roof renovation of historic buildings "Old Town Hall" in Košice.

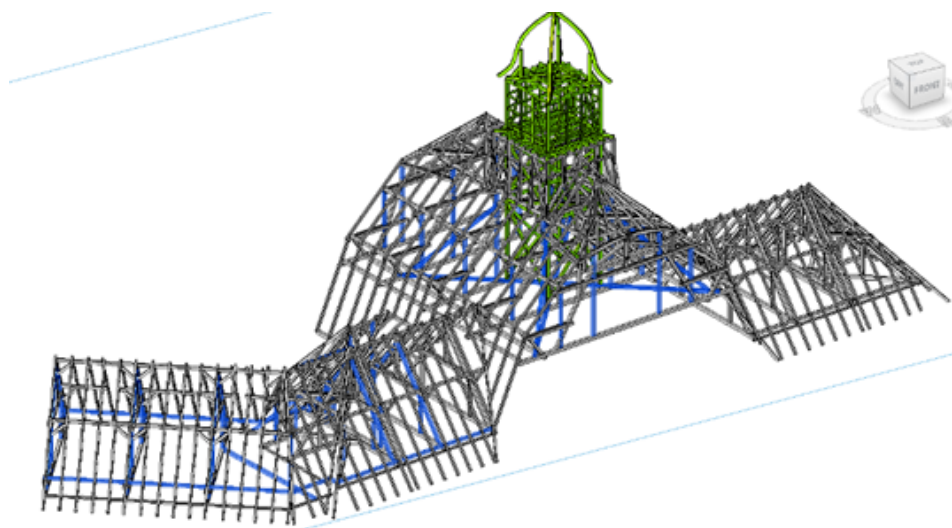
Fig.5 3D model of the OTH roof, damaged elements shown in blue, southern view

After strength tests, it was found that the wooden slope roof structure has 25 damaged elements that do not meet the strength standard requirements of STN EN 408 + A1. After moisture tests, it was found that the roof has 58 damaged elements.

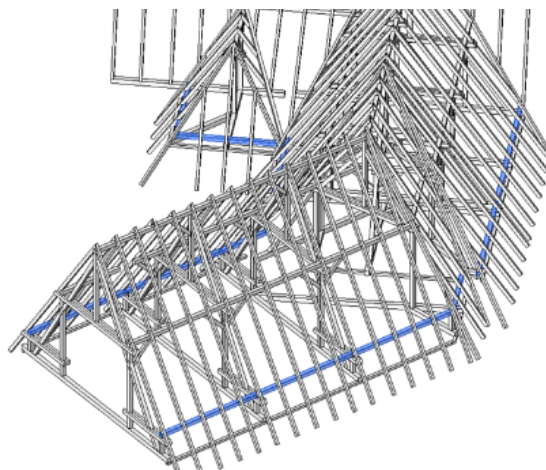
Fig. 6 Spatial identification of a damaged element in 3D model of the OTH slope roof structure

- exact specification of damaged elements - element number, dimension, type of damage, place of damage and results of strength test (Tab.1),
- spatial identification of the damaged element in 3D model of the OTH slope roof structure (Fig.6),
- photo documentation of the damaged element (Fig.7),
- design of remediation technology of the damaged element.

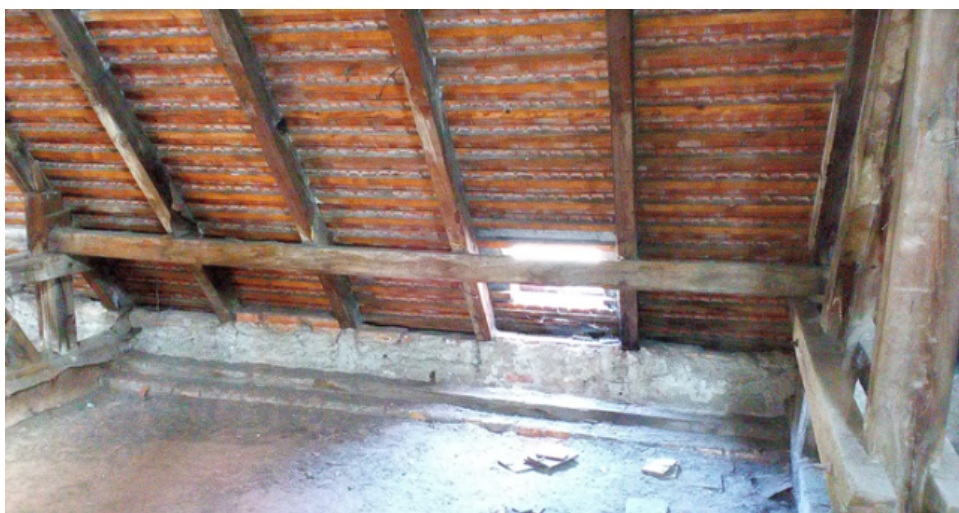
Fig. 7 Photo documentation of the damaged element (purlins)

All damaged purlins were damaged due to strong pressure of rafters. The results of the strength tests showed that the purlins were 1.4-2.4 times more stressed than specified by the standard requirement. This happened because the rafter exceeds the roof limit of 2.5 meters and the purlin is the last support point of rafters. As a result based on a static calculation, all purlins have a sag about 8 cm.

For damaged purlins were proposed two possible options for recovery:

1. Supporting purlins with wooden elements
2. Supporting purlins with steel elements

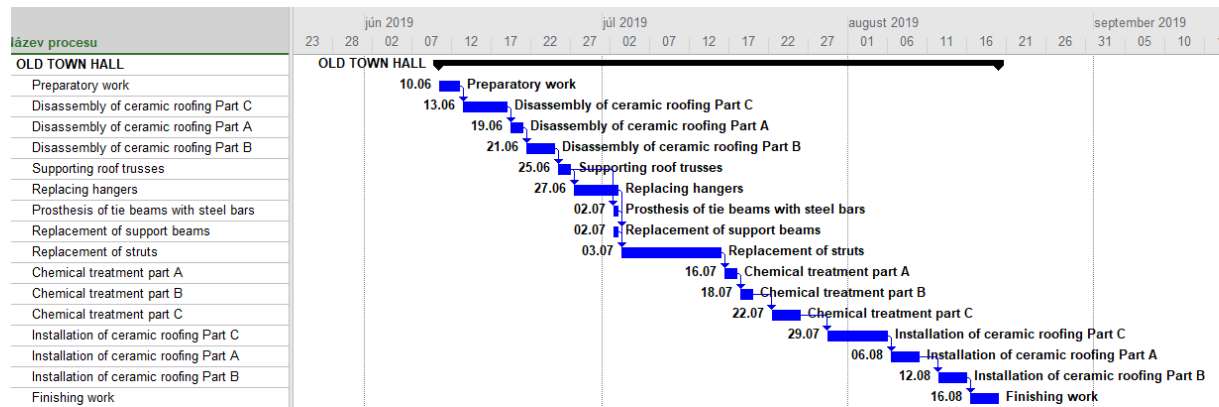
Fig. 9 timeline of the 2nd recovery alternative

The start of the implementation of the renewal of the slope roof structure of the OTH 2nd alternative is planned for 10.6.2019 and the end on 14.8.2019. The first stage will be preparatory work and then the original ceramic roofing will be a dismantling. Then it will realize installation of ceramic coverings.

Next will be the stages of supporting slope roof structure, replacement of hangers, prosthesis of tie beams with steel bars, replacement of support beams, replacement of braces, chemical treatment. Finally, the finishing works will be carried out. The entire renovation will take 48 days.
